PHASE I AFTER ACTION REPORT

BORIT ASBESTOS SITE AMBLER, PENNSYLVANIA

**BoRit Asbestos Site
www.epaosc.net/BoRit**

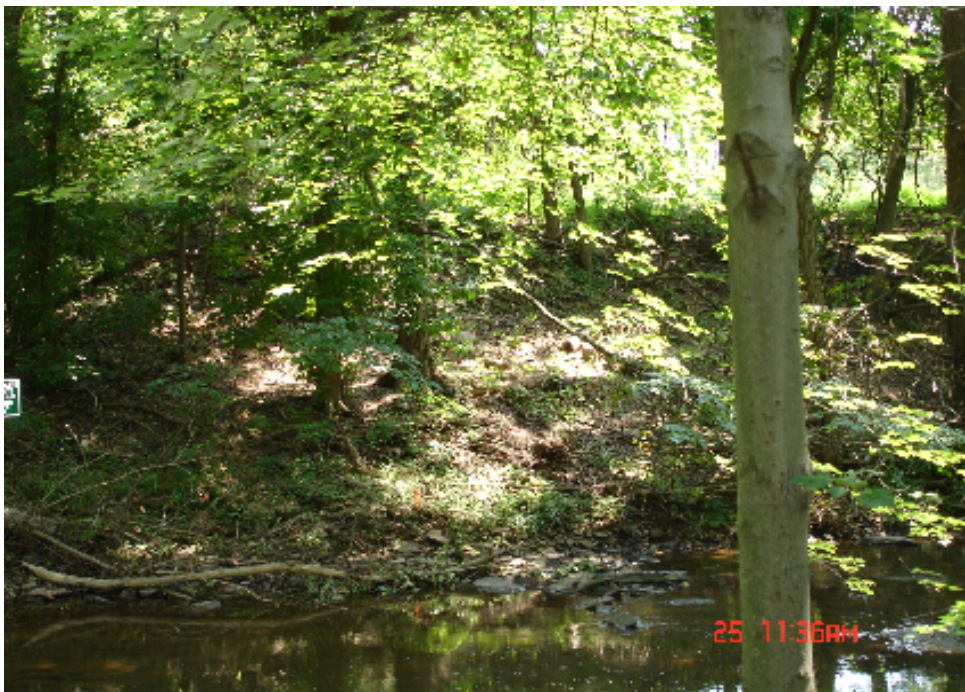
View of the east bank of the Wissahickon Creek prior to clearing / grubbing operations.

The photograph was taken from the Whitpain Township utility (sewer) easement, located on the other side of the creek.

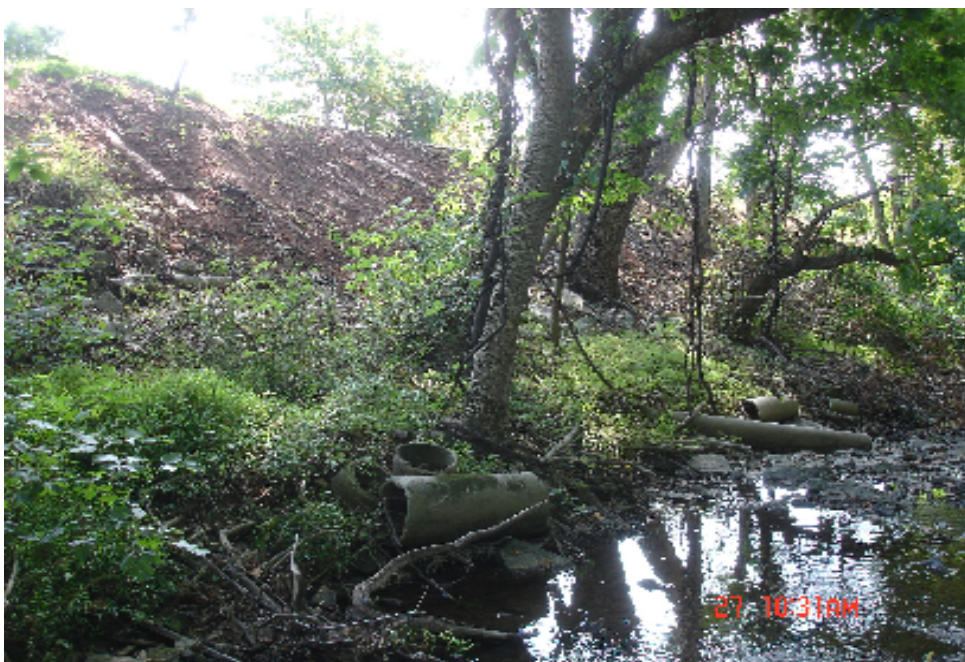
Close-up view of Asbestos-Containing Materials (ACM) exposed on the east bank of the Wissahickon Creek prior to Phase I activities.

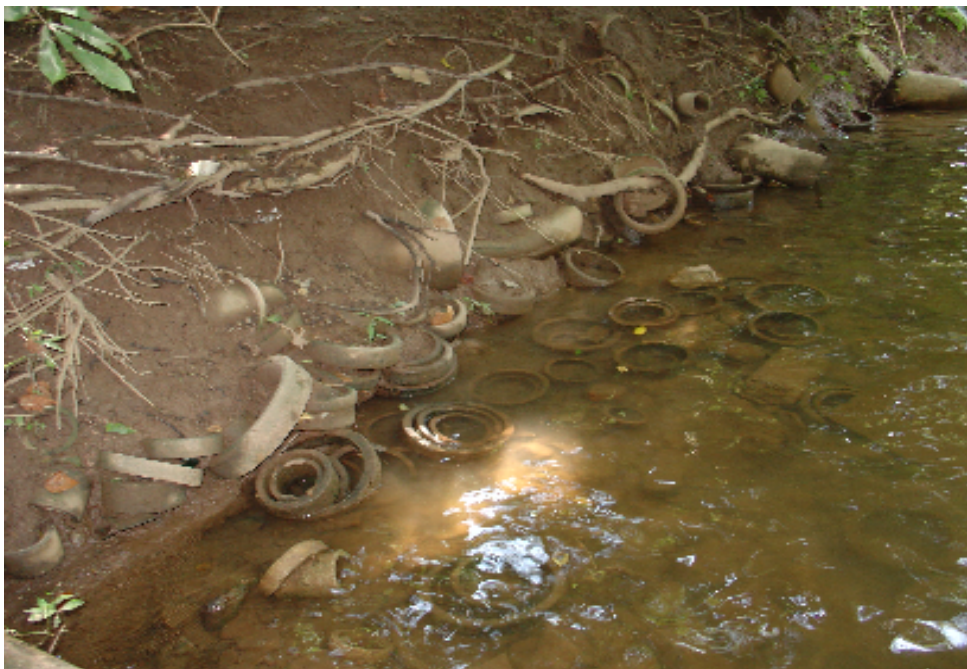
Second close-up view of ACM exposed on the east bank of the Wissahickon Creek.

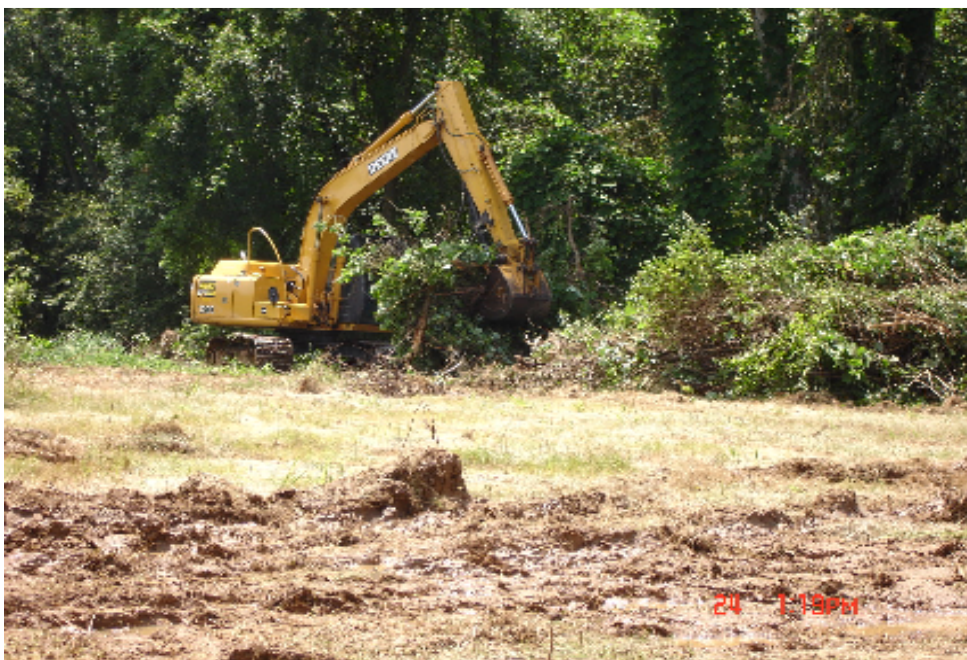
An excavator clearing the east bank (next to the park area) of Wissahickon Creek.

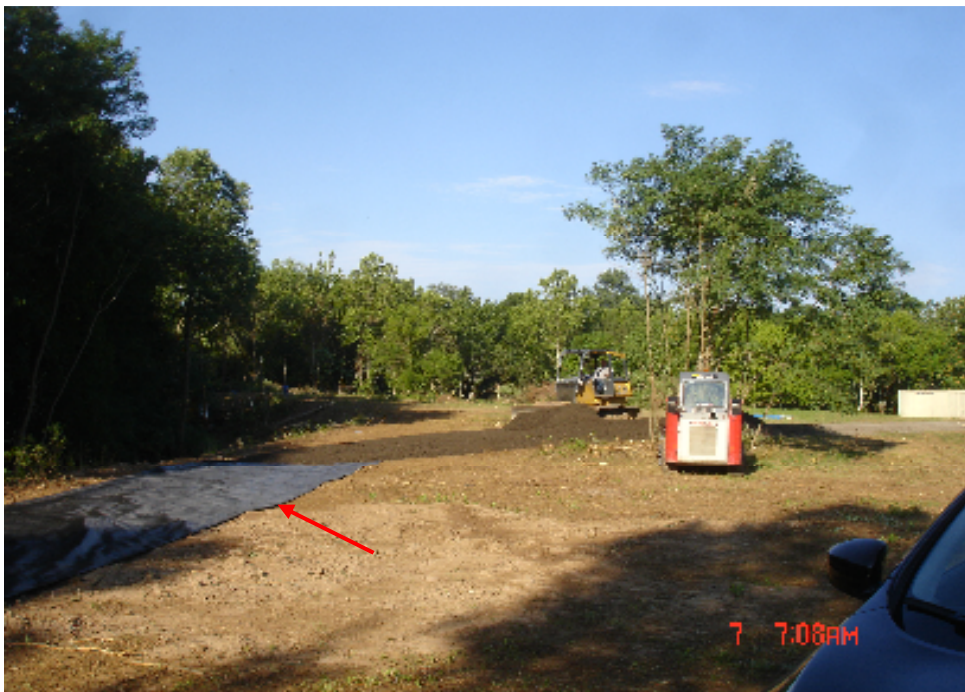
ERRS constructing a gravel access road along the upper bank of Rose Valley creek. Woven geotextile (Mirafi 500x) was used as the base of the road (see arrow).

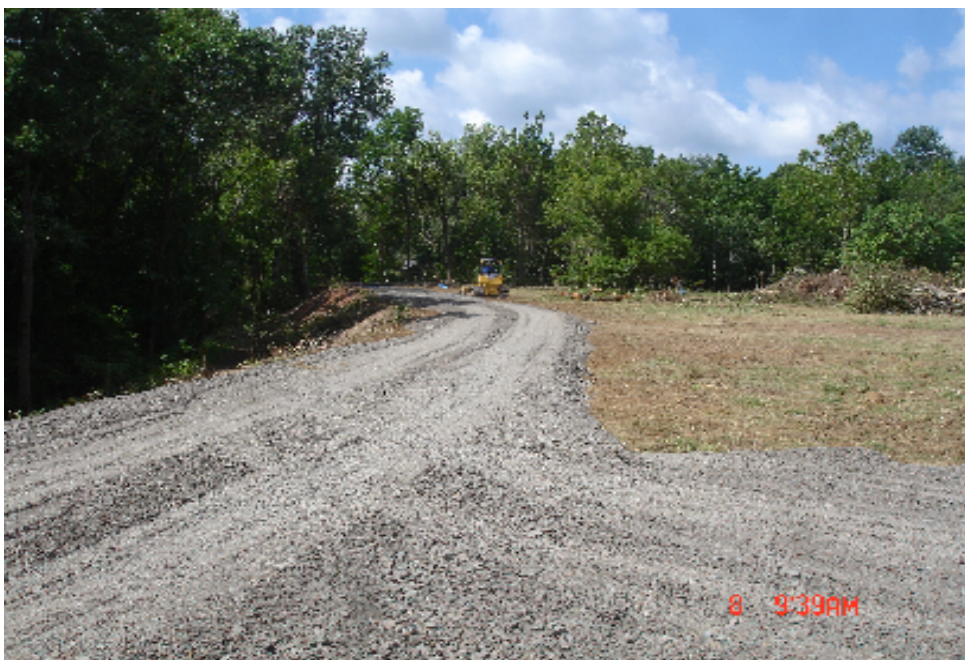
View of the completed site access road constructed with woven geotextile and No. 57 stone.

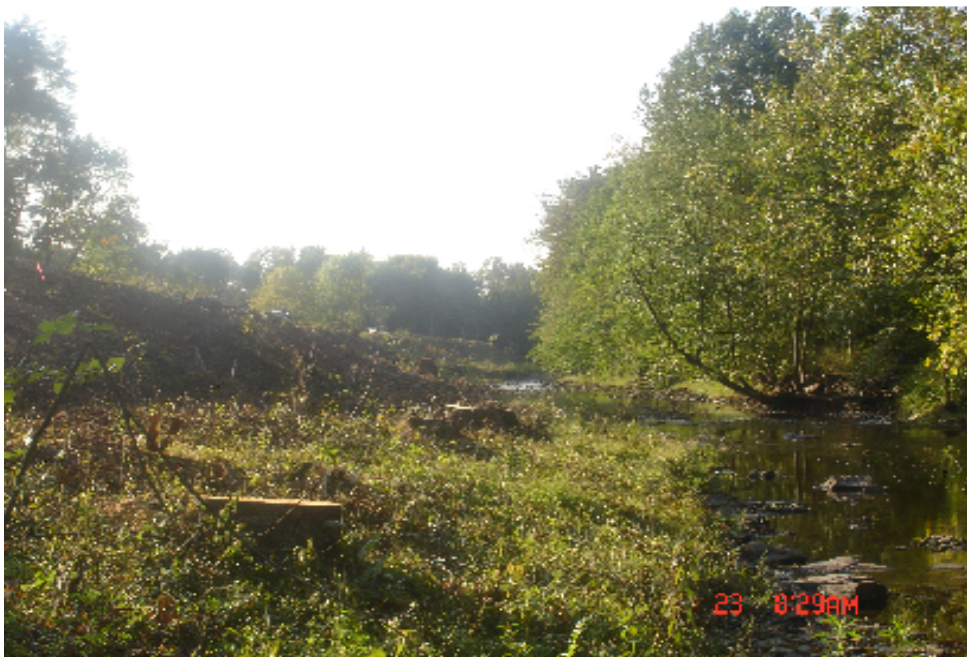
View of the east bank of Wissahickon Creek after removal of large trees. Tree stumps are still visible along the bank. The creek is visible at the right corner of the photograph.

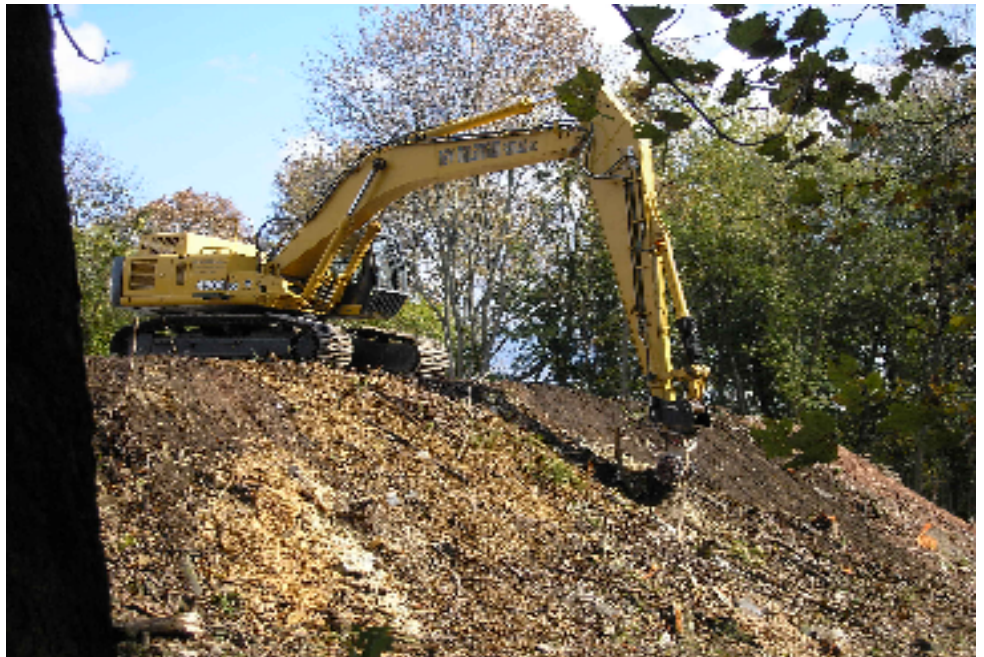
ERRS using a grinder attachment to reduce/level the remaining tree stumps with the surrounding slope on the east bank of the Wissahickon Creek.

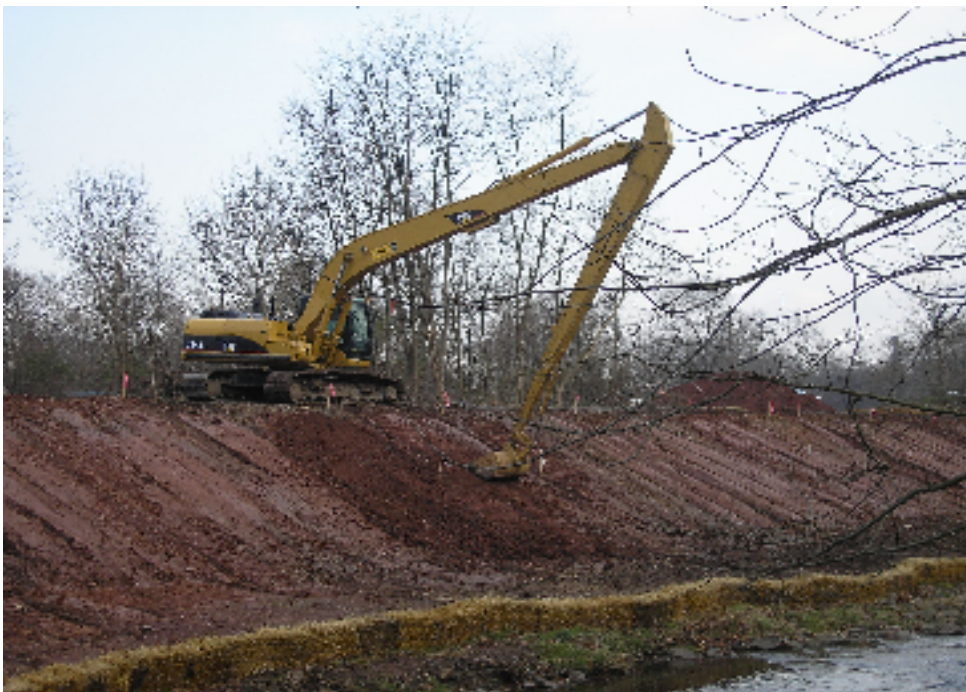
ERRS is placing and compacting clean fill along the east bank of Wissahickon Creek to prepare the slope for upcoming erosion and sedimentation control activities.

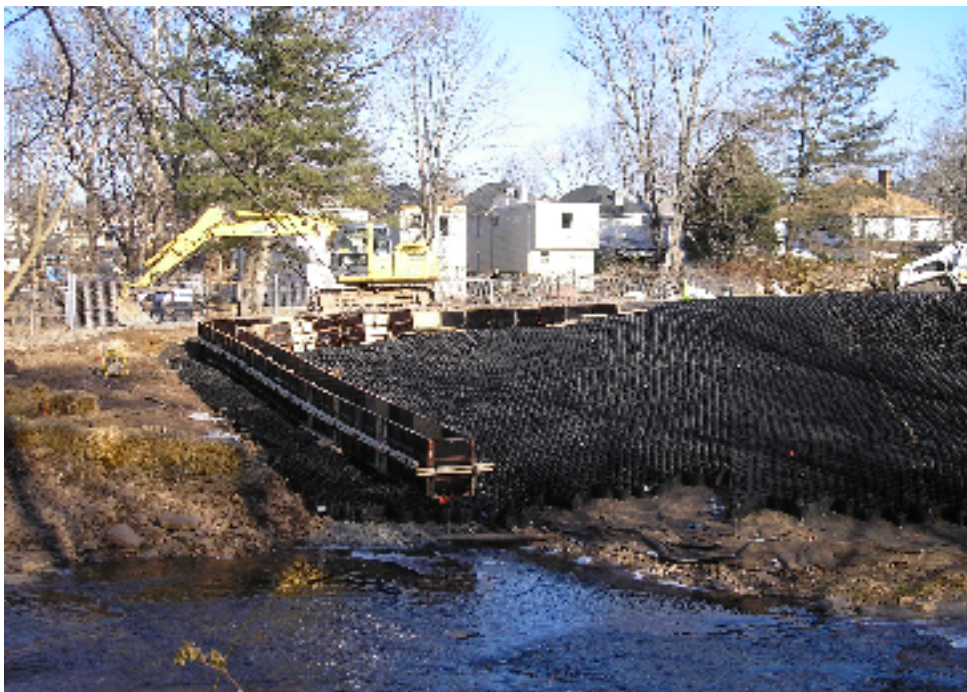
View of wooden forms for the concrete anchor at the north end of the site. The anchor acts as deadweight over the Geocells. The deadweight is required to prevent the Geocells from being undermined during a major storm event.

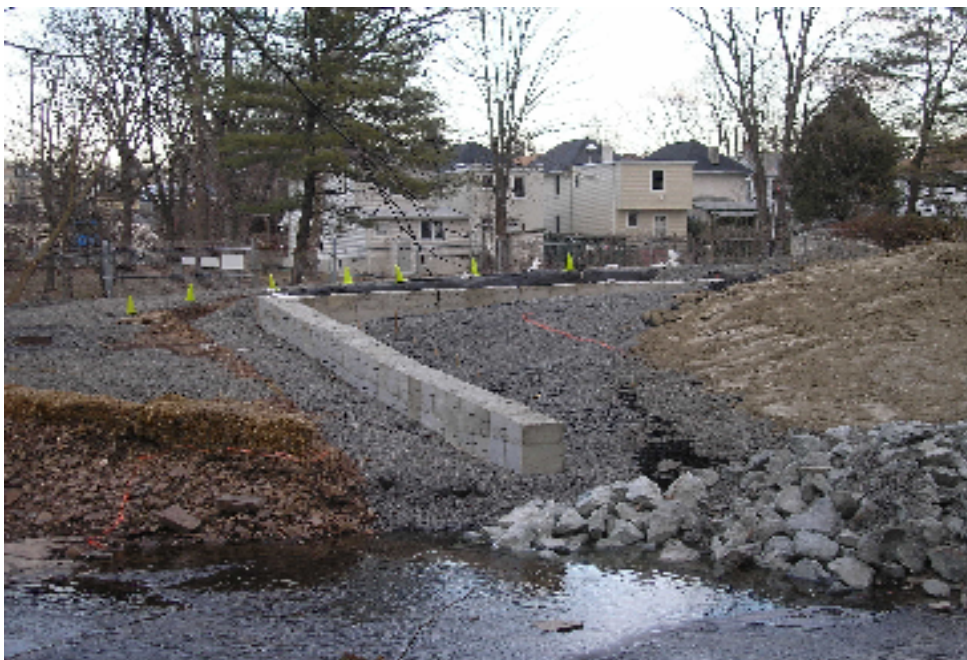
View of the completed concrete anchor prior to being covered with riprap. The Geocells around the anchor are filled with No. 57 stone before being covered with riprap and/or topsoil.

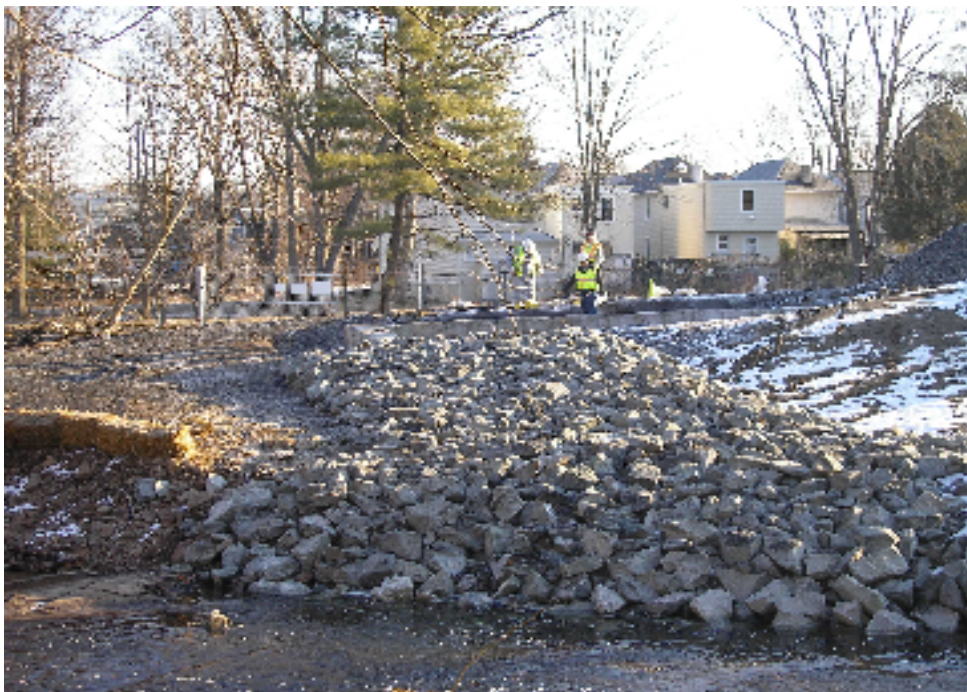
View of lower portion of concrete anchor covered with riprap; the upper portion (where people are standing) was covered with topsoil.

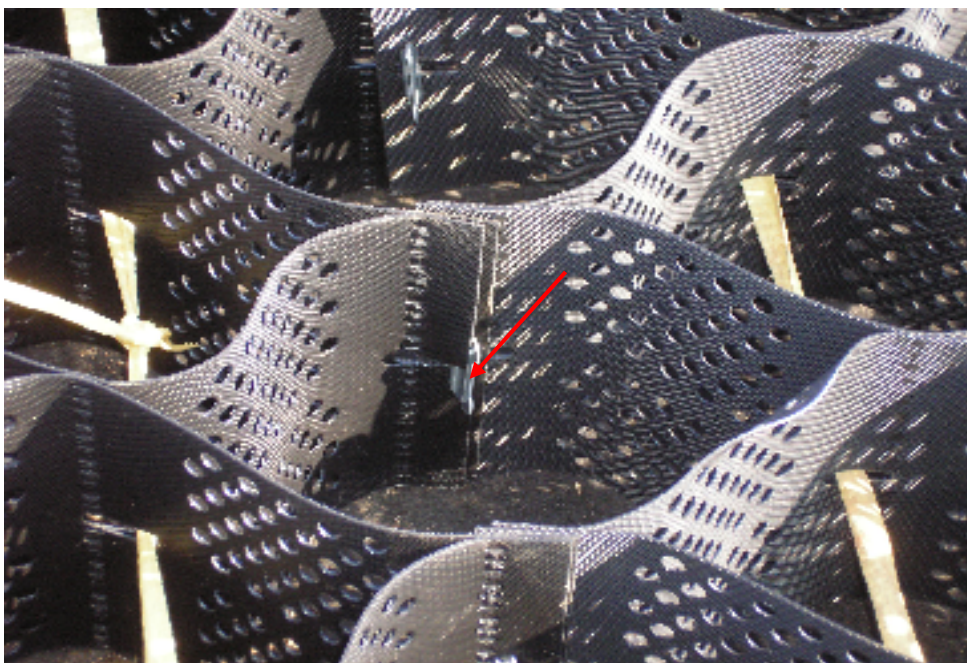
Close-up view of individual Geocells. The ATRA keys (see red arrow) were used to connect adjoining sections together. The yellow Kevlar tendons are connected to anchors installed along the top of the upper bank.

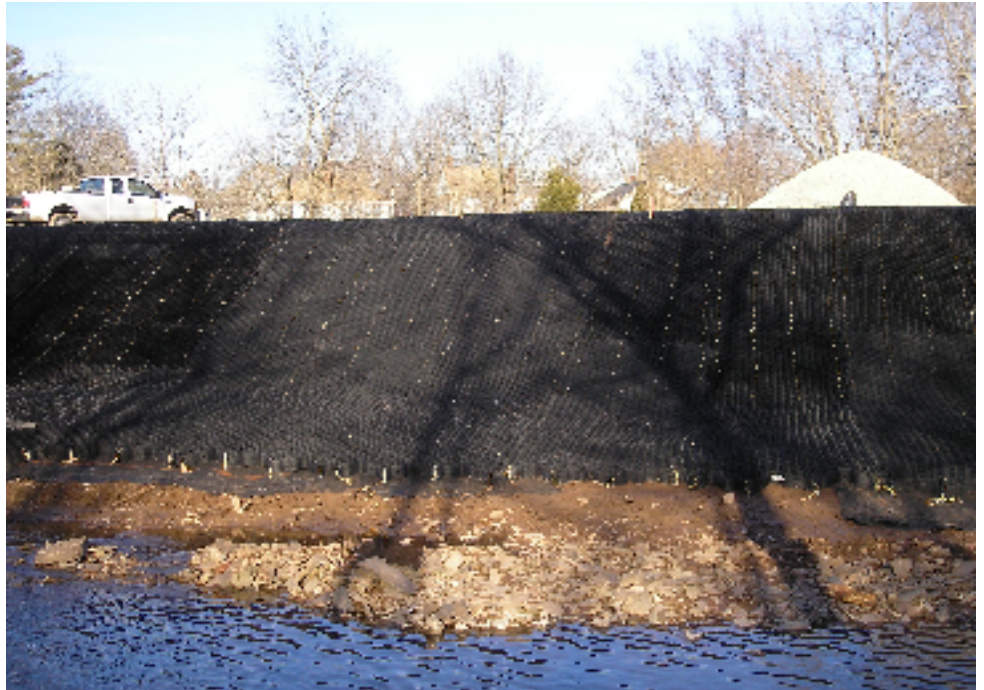
View of Geocells sections installed along the east bank of the Wissahickon Creek. Photo taken from other side of the creek.

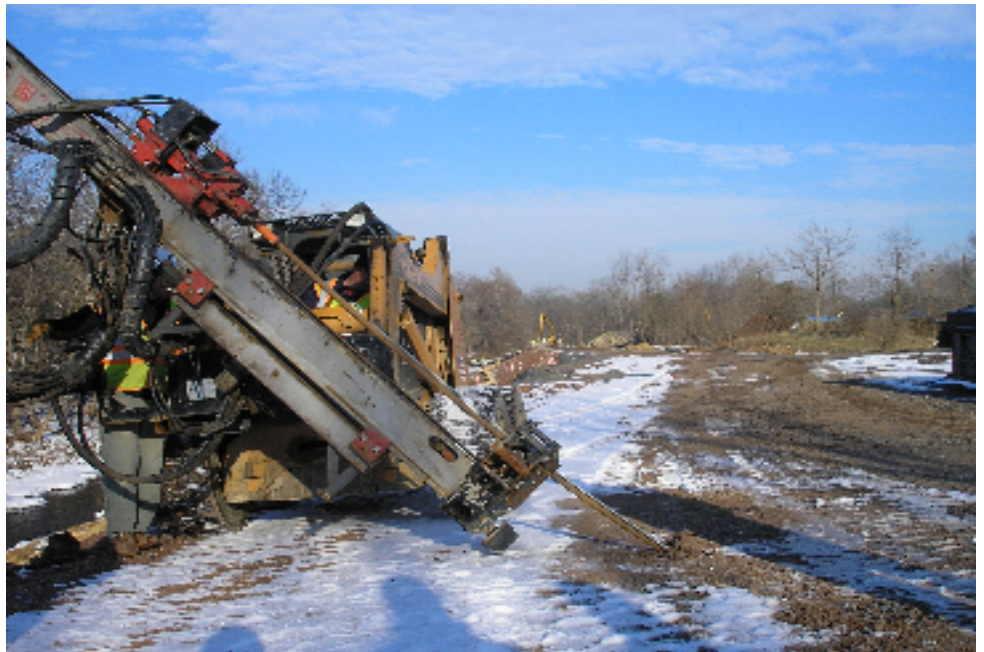
View of the equipment used to install the MR-4 Manta Ray anchors. The anchors are used to tie the Kevlar tendons passing through the Geocells up the slope.

1. Manta Ray (MR-4) anchor installation: The original design specifications had called for the installation of the anchors through the use of pilot holes; however, it was found to take too much time to install each anchor. After some research and discussions, EPA and its contractors decided that the anchors would be installed via a direct-push technique. A subcontractor came on-site and installed the anchors. Subsequent to the installation, each anchor was tested with a load of 2,200 psi pressure for a period of two minutes. If the pressure dropped by more than 200 pounds per square inch within the 2-minute timeframe, or if the rod pulled more than 18-inches out of the ground, the anchor was considered to have failed.

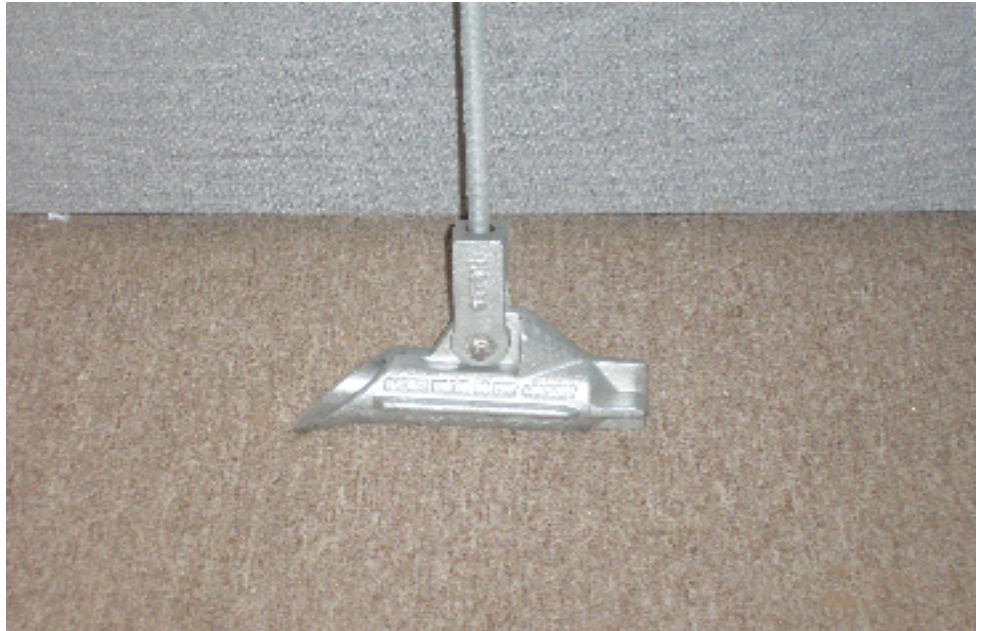
Close-up view of the MR-4 Manta Ray anchors used to secure the Geocell sections along the slope. The rod at the top of the anchor is 6 feet long with an eyebolt at the top threaded rod; the Kevlar tendons are tied to the eyebolt and the bottom of the rod is screwed into the anchor itself.

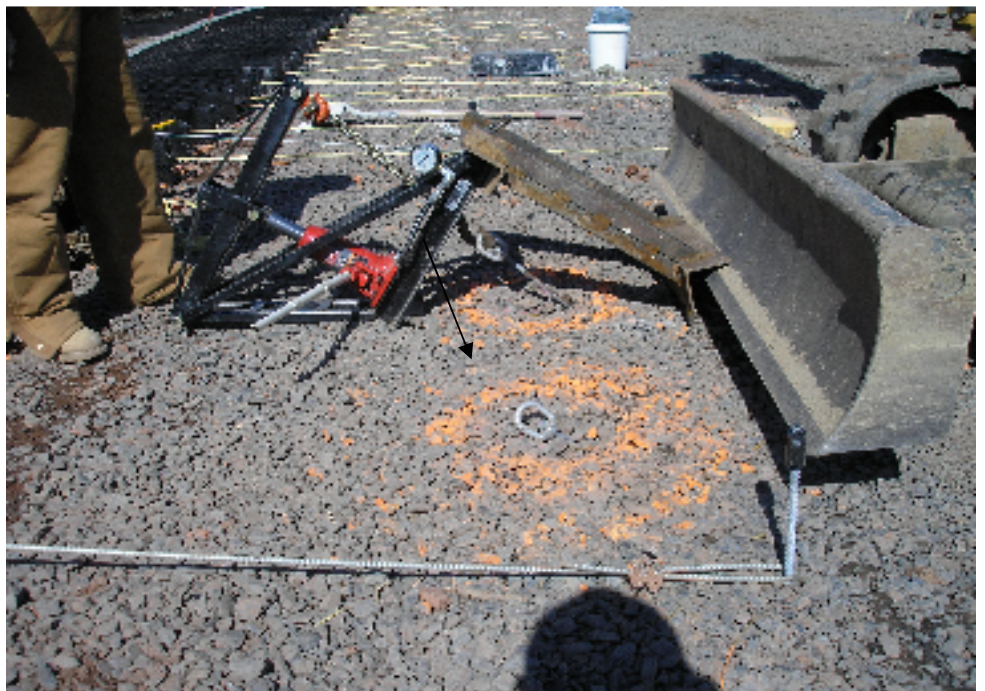
Close-up view of the hydraulic jack used to test the anchors installed to secure the Geocells sections along the slope. If any anchor failed to pass the load test, a replacement anchor was installed.

2. Manta Ray (MR-4) anchor failure: Approximately 21 (of 560) anchors failed the load test. Some anchors failed to hold the test pressure for the specified length of time and others broke. Each time an anchor failed or broke, the location was moved and the anchor was replaced by a new anchor that passed the load tests.

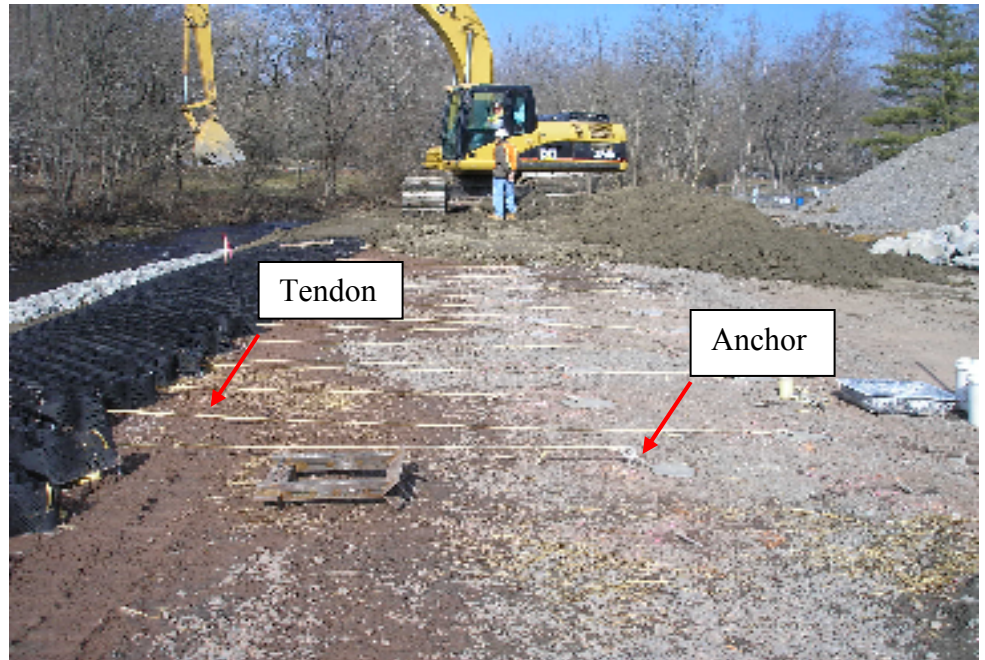
View of the Kevlar tendons (see arrow) from the Geocell sections secured to anchors (see arrow) that have passed the load test.

In the background, the long reach excavator can be seen filling the Geoells with topsoil.

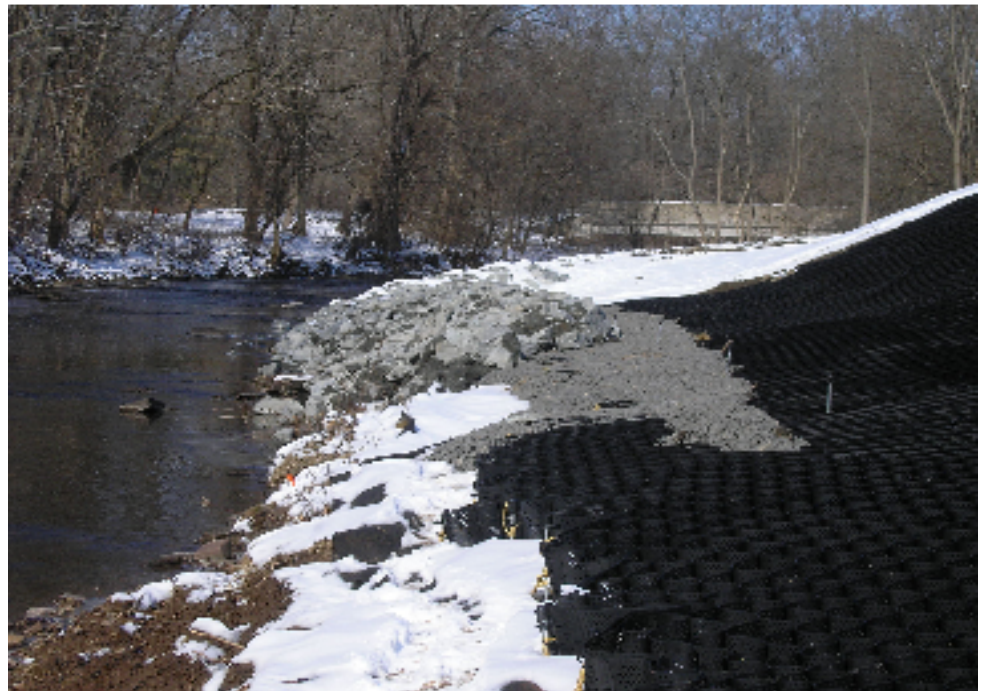
View of the lower portion of the Geocells. Approximately the first 6 feet (lower portion) of the Geocells were infilled with No. 57 stone prior to covering with R5 riprap.

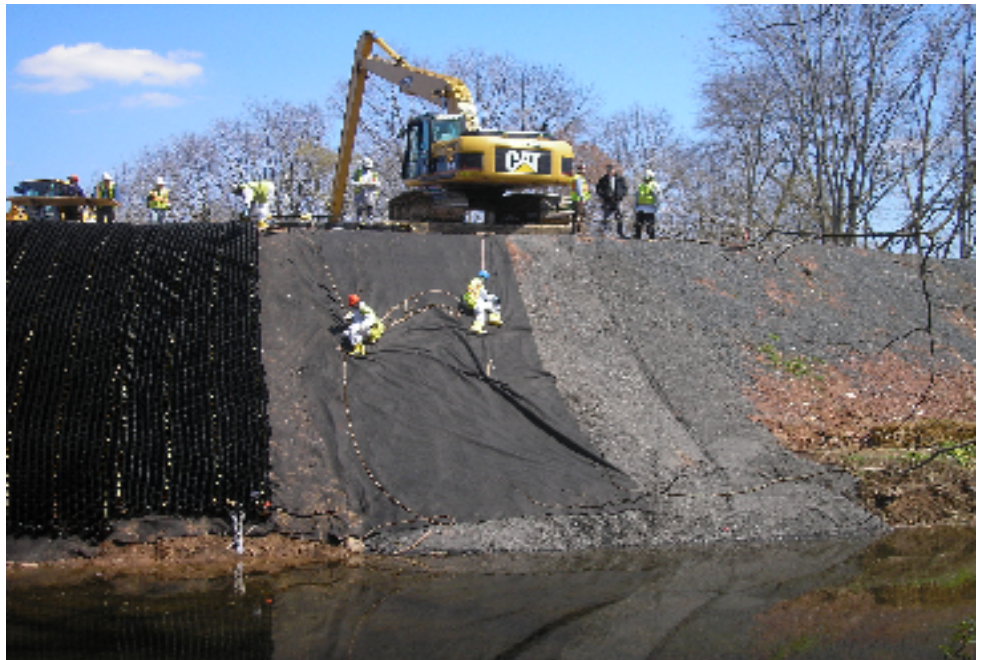
Photograph taken from the easement located on the other side of the creek. ERRS is placing the 10-ounce non-woven geotextile along the slope. The geotextile is placed below the Geocells. At the left, placement of Geocells is complete.

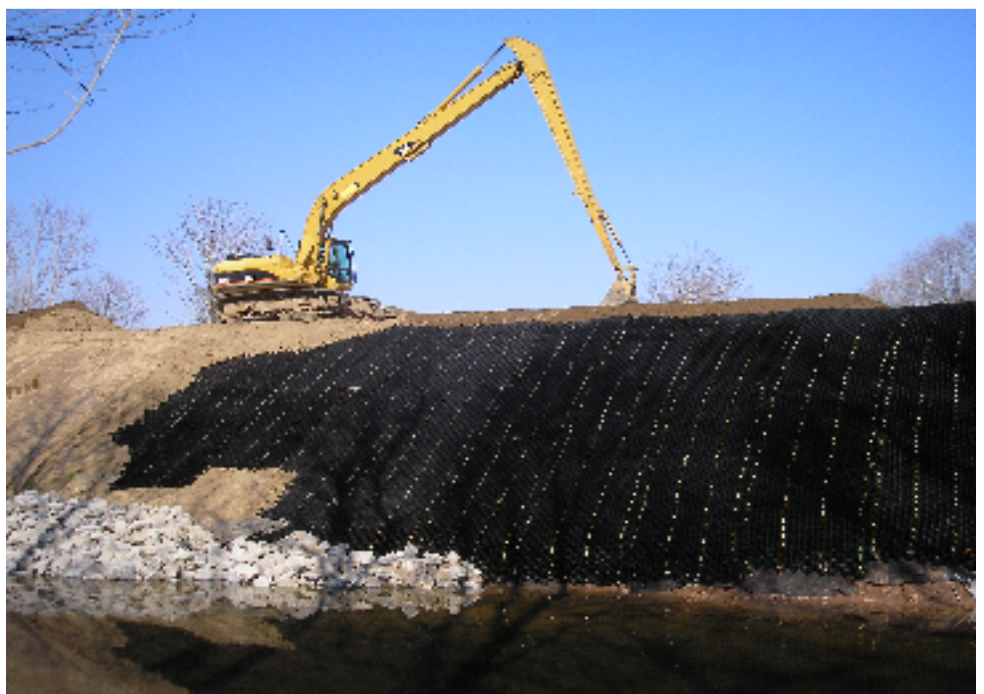
ERRS continuing to infill installed Geocell sections. Geocells were infilled with No. 57 stone at the bottom, and with topsoil to the top of the slope.

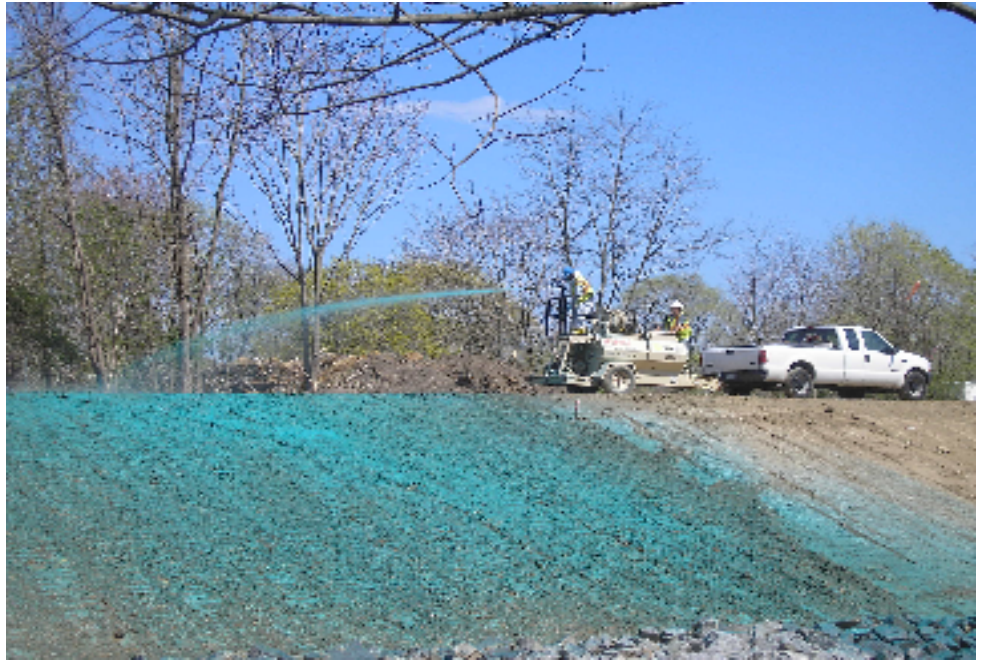
Installation of Erosion and Sedimentation Control (ESC) is complete. ERRS is hydro-seeding over the Phase I area.

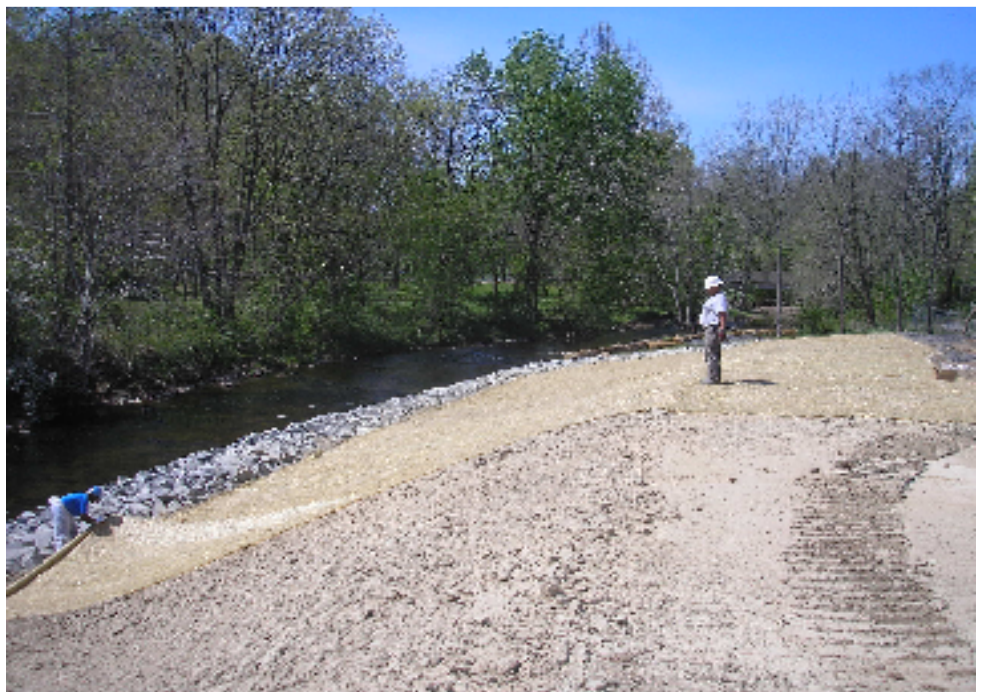
ERRS installing erosion control mats on the slope where hydroseeding activities have been completed. The erosion control mats protect the seeds from adverse conditions and allow the seeds to germinate quickly.

Once everything was in place, the entire slope was hydroseeded and then an erosion and sedimentation control mat was placed along the slope to protect the seed from adverse weather conditions and to create a moist environment underneath, for best germination of the seeds.

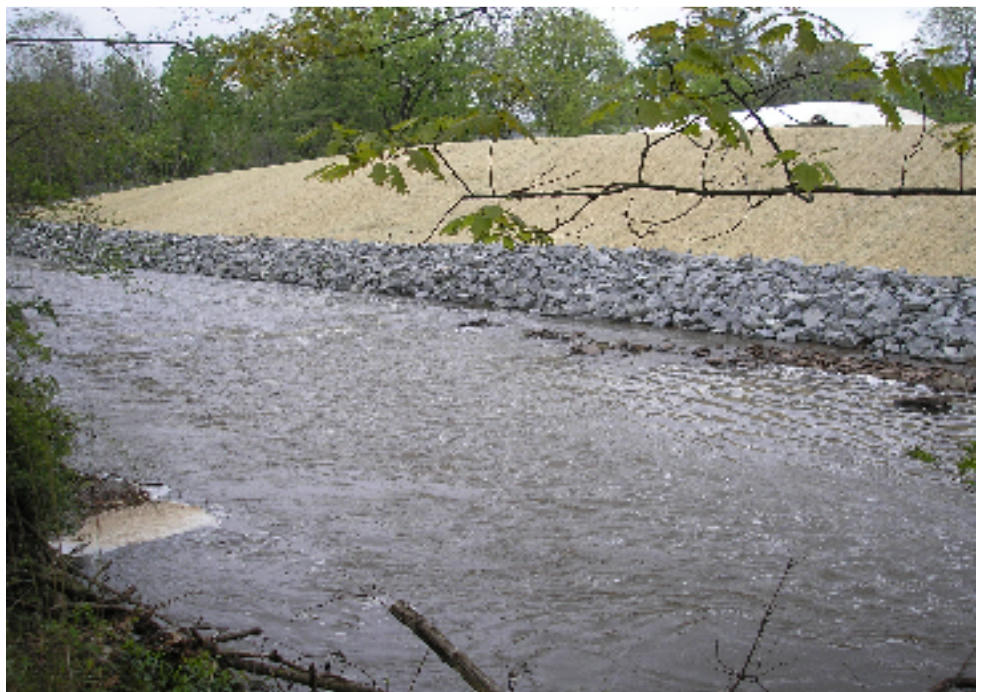
The photograph was taken from the easement, located on the other side of the creek. One major storm event occurred in the evening on May 5, 2009. All low-lying sand bars are under water.

Since its completion, the Phase I design has been tested several times and no evidence of real impacts along the Phase I section has been observed. Based on the precipitation (approximately 4 inches in 24 hours) and the water level on the Wissahickon and Rose Valley Creeks, the storm events could be compared to the projected 25-year flood stage, possibly even a higher stage. All the R5 riprap along the slope was under water and the debris line left on the slope was about two feet over it. Even with storms of that magnitude, the R5 riprap was still in place and there were no visible erosion channels along the slope.

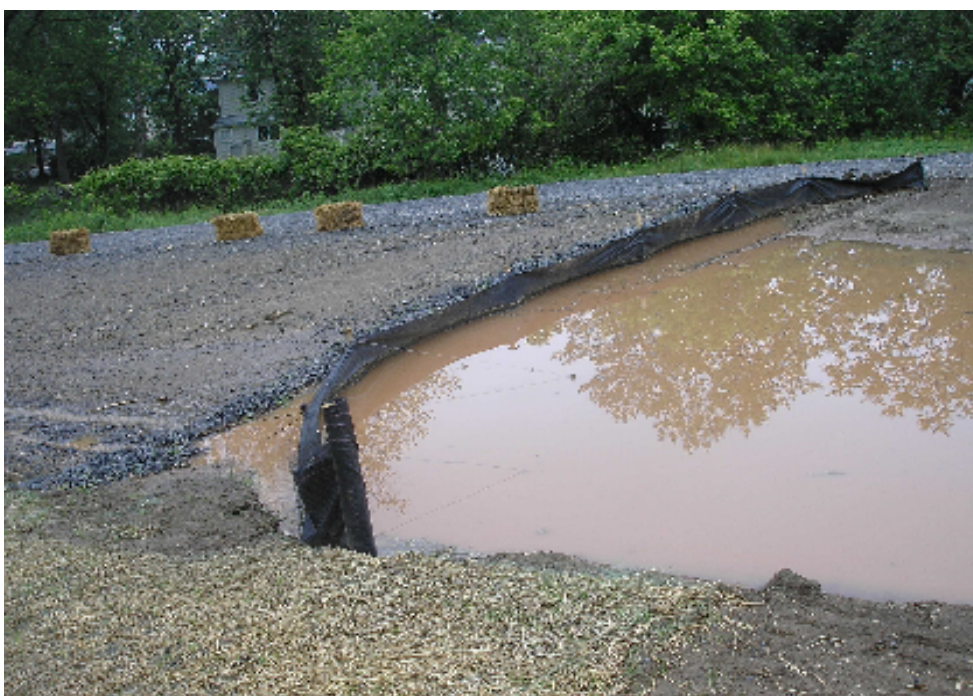
Description: The former tennis court after a major storm event occurred on the night of May 28, 2009. The silt fence located north of the tennis court holding water/silt.

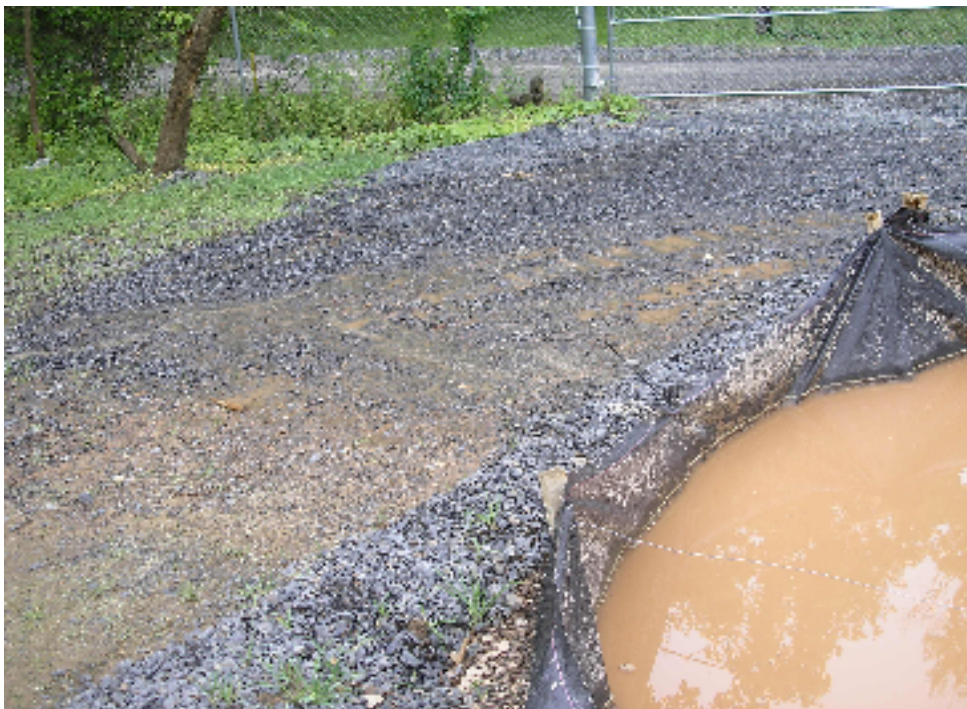
The second silt fence located at the north end of the park area. The North gate is visible at the upper right corner of the photograph. The silt fence is holding accumulated water and silt after a heavy rain.

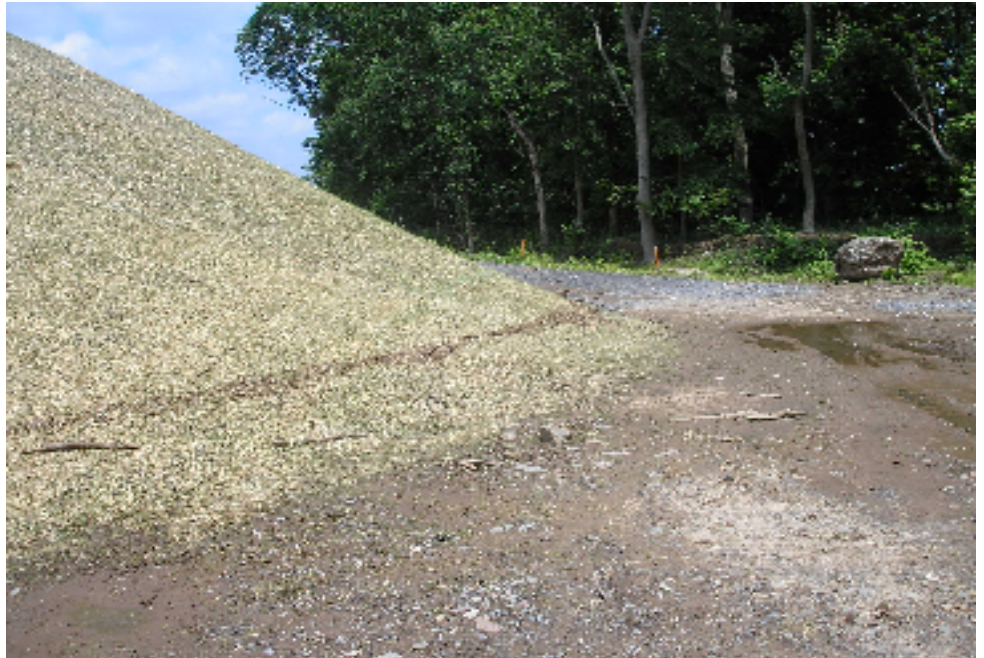
At the confluence of the Rose Valley and Wissahickon Creeks, the water level rose approximately 2.5 to 3 feet from the base of the Geocells area. Rising water left a debris line along the slope. The rising water caused no harm to the newly constructed slope with Geocells.

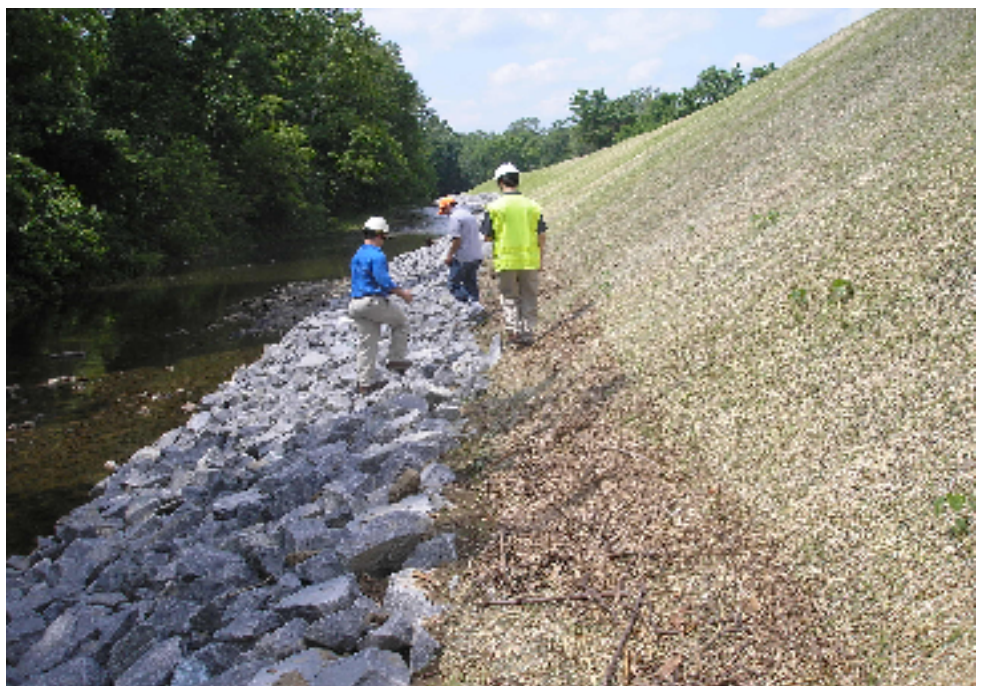
Due to heavy rain, the water level rose approximately 2 to 3 feet above the riprap; the debris line can be seen at the right. The Engineering Inspector for Whitpain Township (seen at left) accompanied the EPA OSC (center) to inspect the integrity of the Phase I design.

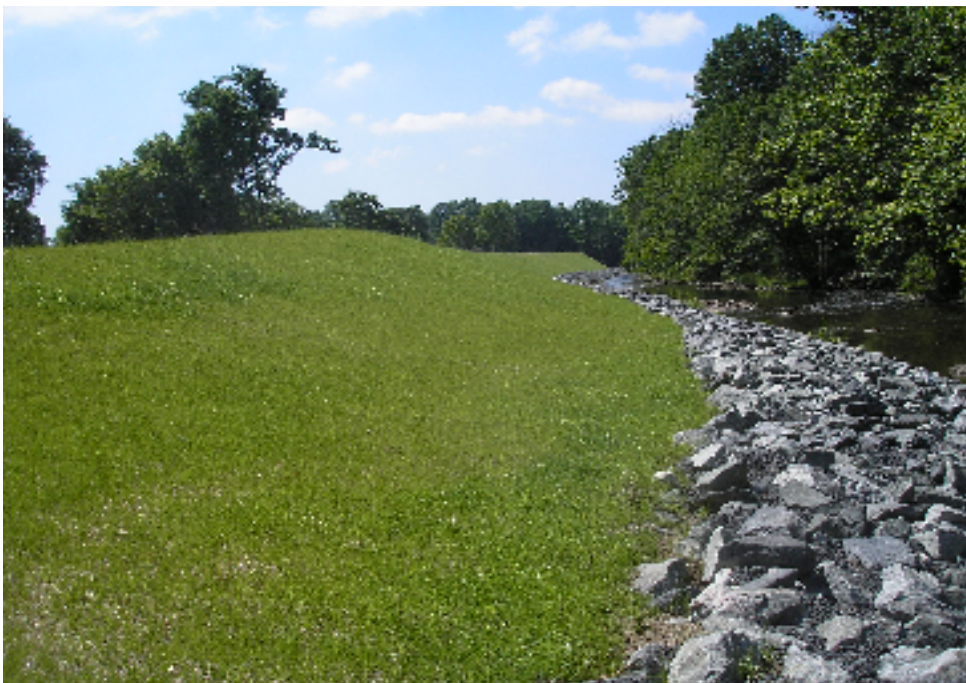
View of the completed Phase I slope. The seed mixture used on the slope was ERNST 181.
